RESTORATION OF DAMAGE TO A PROVINCIAL ROAD IN THE REGION OF ATTICA (GREECE) AFTER A DISASTROUS WEATHER EVENT

NIKOLAOS TAVOULARIS ¹, AGGELIKI KONSTANTARA ¹, AGGELIKI ZIAVRA ¹, LEONIDAS SOTIROPOULOS ²

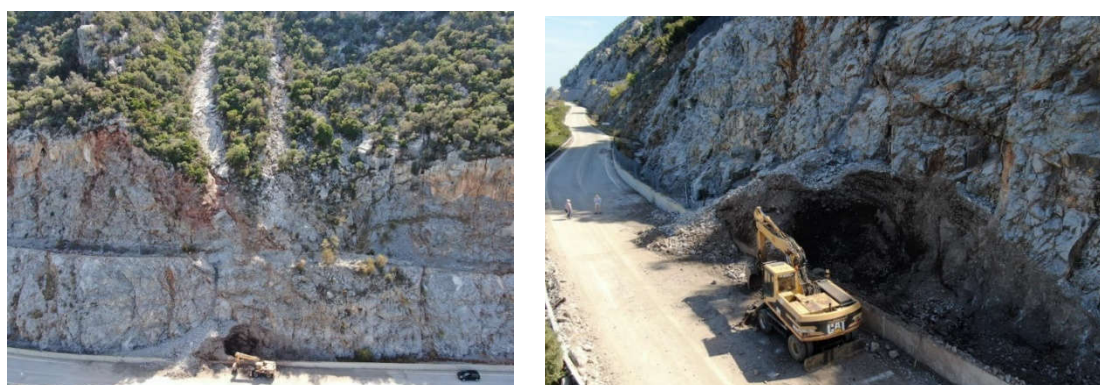
The main geomorphological features observed that affect the occurrence of soil instabilities are a) the steep overhanging slopes and b) the intense erosions and gullies within the streams and torrents that flow into the road (Figure 2).

Figure 2. Debris cone and alluvial material at the base of the slope and within the road, from material accumulated through the two talweg - gullies.

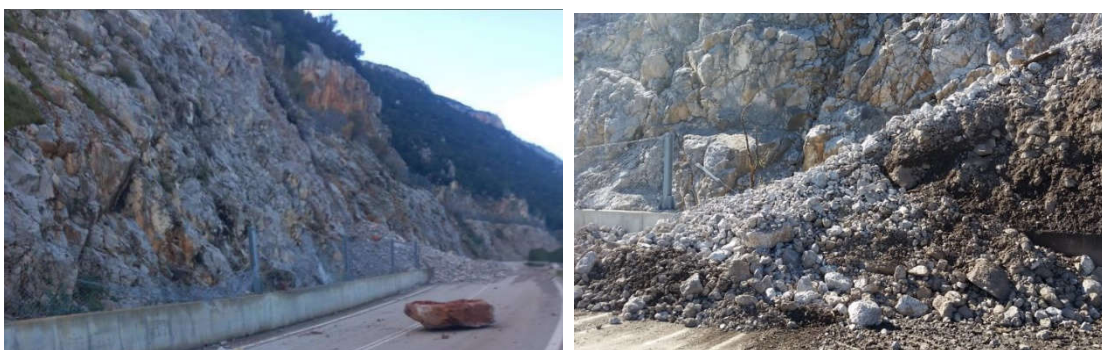
Apart from bedding planes, five (5) sets of discontinuities were encountered. According to the evaluation of the Schmidt diagrams, two common failure mechanisms were identified: rock toppling and rock wedge sliding. In actual conditions, locations of rock fragment detachment, mainly large-size rock 'wedges', and the occurrence of toppling or falling/detachment of overhangs were found. A typical rock wedge failure that caused serious damages to the existing metal barrier is presented in Figure 3.

Figure 3. Falling of an individual boulder of 8m³ (maximum boulder size of the rockfall) that bounced off the existing protection measures and ended up on the road deck within the provincial road, at about Ch. 5+525 km. Close-up view of debris flow (on the right)

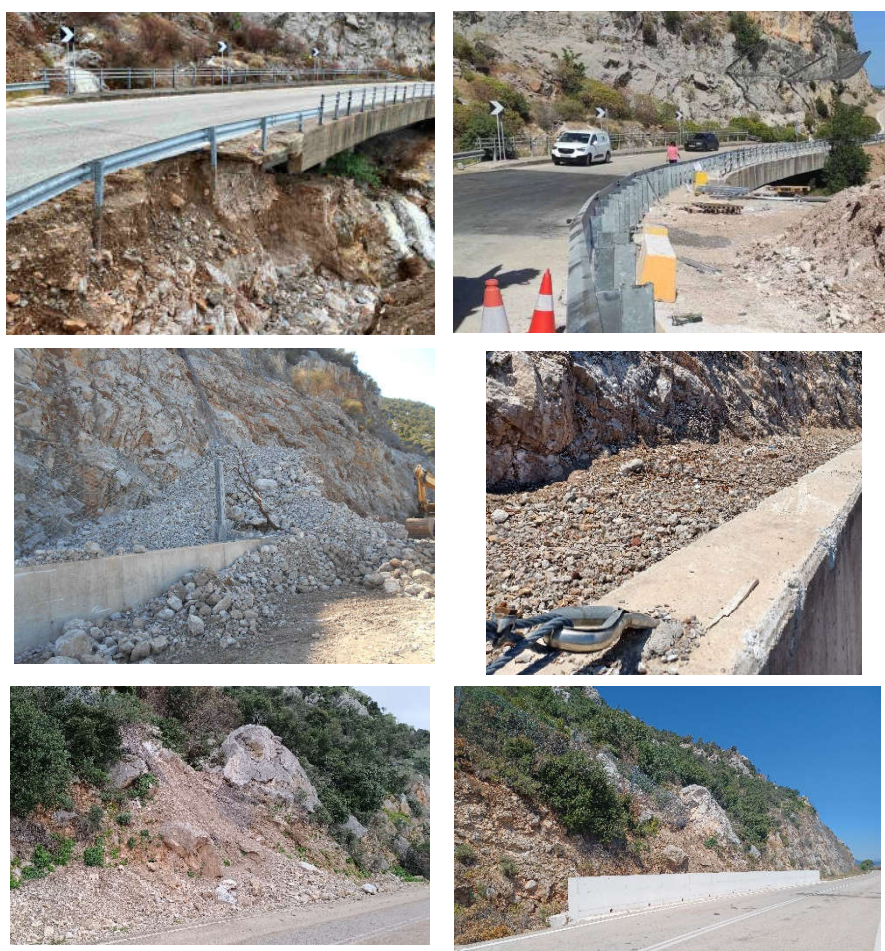
Figure 6. Characteristic views after the devastating heavy rainfall “Daniel” (left side) and restoration works (right side)

1. In some locations, precarious rock blocks perched on the top of slopes were identified. Their potential failure risked the subsequent accumulation of a significant volume of material in the rock fences, rock traps and road deck. For these reasons, scaling and rock removal works took place to improve the stability of the existing slopes and to safely perform further the interventions.

2. The accumulation of debris flow materials was found on the benches and behind the rock traps and metal fences along almost the entire section of the road, which were removed to ensure their proper function and to allow collection of similar future phenomena.

3. Permanent deformation and/or complete failure of existing measures was observed in several locations. At these locations, their functionality was checked and the repair and/or replacement of existing structures that have been deformed or completely failed (Rock barriers, rock fences, steel meshes, reinforced concrete walls, etc.) was required.

4. Repair works of embankments and deck sections of the road were executed.
5. Anchoring of free meshes was implemented.
6. In some locations, the scaling of “keyblocks” was considered ineffective due to the potential precipitation of larger scale failures. In these cases, spot bolting of individual rock blocks was carried out.
