## COLLAPSE OF THE SCHIEBURG TUNNEL IN LUXEMBOURG: GEOLOGICAL CAUSES AND EMERGENCY SECURING WORKS

On 27 August 2022, a collapse occurred in the Schieburg tunnel during repairs on the vault. Around 400m<sup>3</sup> of debris flowed out in a matter of seconds, completely blocking the tunnel and the only railway line serving the north of Luxembourg towards Belgium. The rockfall occurred 60m from the southern entrance, at a point where the overburden above the tunnel is 31m. The geological and geotechnical studies carried out included reconnaissance boreholes with parameter recording to a length of 80m, geophysical prospecting using electrical and seismic tomography, and a structural study of outcrops in the vicinity of the tunnel. These investigations revealed a highly complex geological situation, with the rockfall zone located at the intersection of a system of conjugate faults not recorded on the geological maps. The results made it possible to estimate the volume and shape of the deconsolidated zone above the collapse, and to propose safety measures to reinforce the deconsolidated zone above the tunnel, safely remove the cone of scree and repair the vault. Geotechnical monitoring

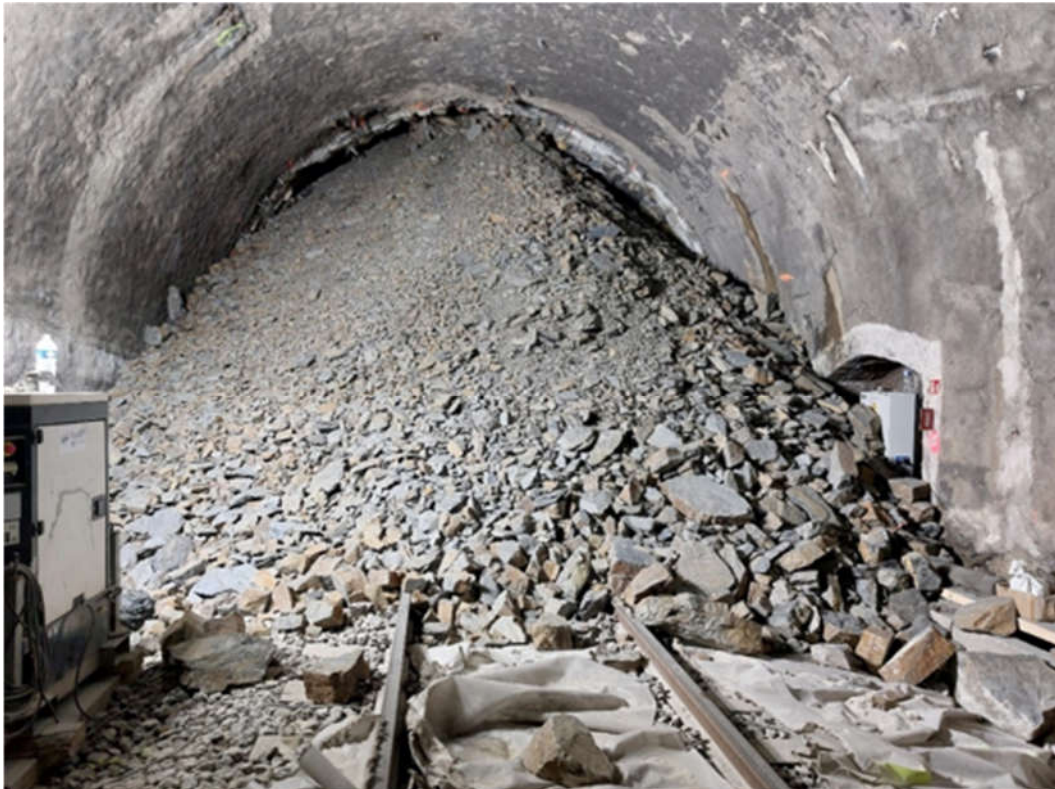
A collapse occurred in the Schieburg tunnel (built in the 19th century) in Luxembourg on 27/08/2022 during repair works on the vault, completely blocking the tunnel and traffic on the only railway line linking the north of Luxembourg to Belgium (Figure 1). The rockfall occurred approximately 60m from the southern entrance of the tunnel, at a point where the overburden above the tunnel is 31m, and under a forest canopy.

**Figure 1.** Rock slump seen from the southern part of the tunnel

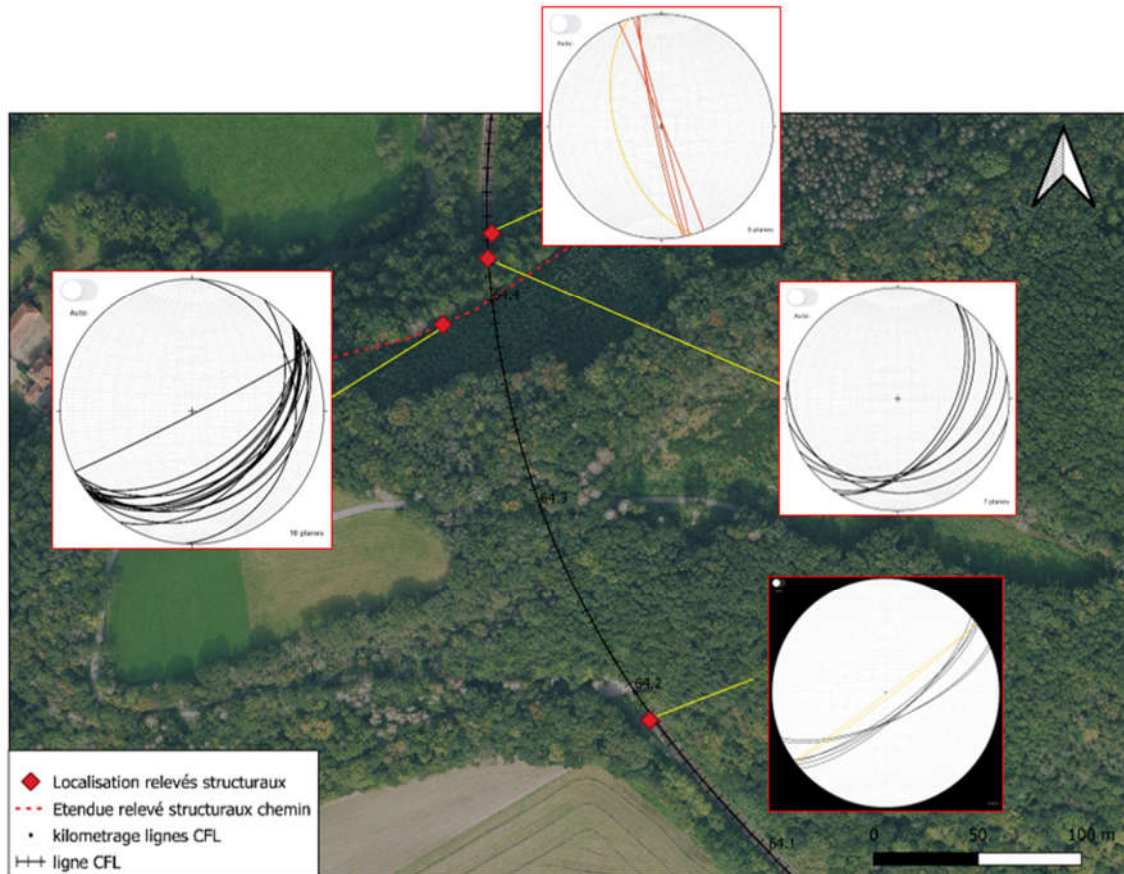
Structural and stereographic analysis revealed a steeper dip (70°) for the stratification near the scree cone than near the northern exit of the tunnel (48°). Two outcrops are directly accessible at the southern entrance to the tunnel, on either side of the train track. At this point, the stratification on the outcrop on the east side dips to the south at 70° to 75°, while the stratification on the outcrop on the west side dips more steeply at 86° to 89°. This variation in the dip of the stratification over such a short distance could be linked to the influence of a fault. Along the logging road above the tunnel, we see that the dip of the stratification decreases from west to east as we approach the tunnel, and then increases sharply directly east of the northern entrance to the tunnel, from 57° to 23° and then increasing to 51° directly east of the tunnel. There is also a change in the strike for the least inclined beds. This trend was also observed just above the northern entrance to the tunnel, where the dip of the stratification varies between 57° to the west and 17° to the east. Several fault planes were observed along the access path to the northern entrance of the tunnel. Directly to the east of the tunnel, the rock mass is no longer visible, and a zone covered with vegetation and soft ground can be observed. This zone corresponds to the supposed passage of a fault plane. Beyond this zone along the road, the dip of the stratification increases again to 51°.

The various observations mentioned above (see also Figure 2) have clearly revealed a variation in the orientation (strike and dip) of the stratification over very short distances, suggesting the presence of a fault or a fault system probably associated with the main fault shown on the geological map. These fault systems in this kind of rocks are generally linked to folds close to the fault planes and bank-to-bank slides. The presence of beds completely transformed into clay, vitrified elements and the mixture of blocks of variable dimensions in a clay matrix also suggest the influence of a zone crushed by a fault.

**Figure 2.** Variation of the strike and the dip of the stratification (black) all around the tunnel. The fault planes observed to the north of the tunnel are shown in red and yellow on the stereogram in the top center

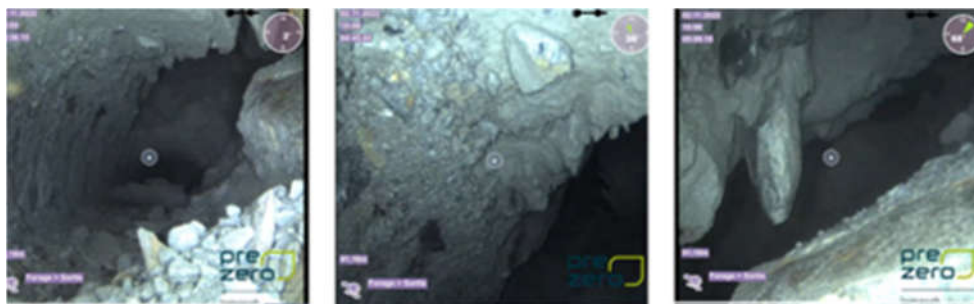
Several camera passes were made in the boreholes. In the deconsolidated zone, the images obtained show the presence of more or less angular blocks and boulders in a clay matrix, as well as numerous voids between the blocks following the rearrangement after the rock slump. The nature of the material is compatible with an area that was crushed following the passage of a fault and subsequently altered by water circulation.

**Figure 3.** Camera pass through borehole 2 showing blocks and boulders of varying sizes in a clay matrix

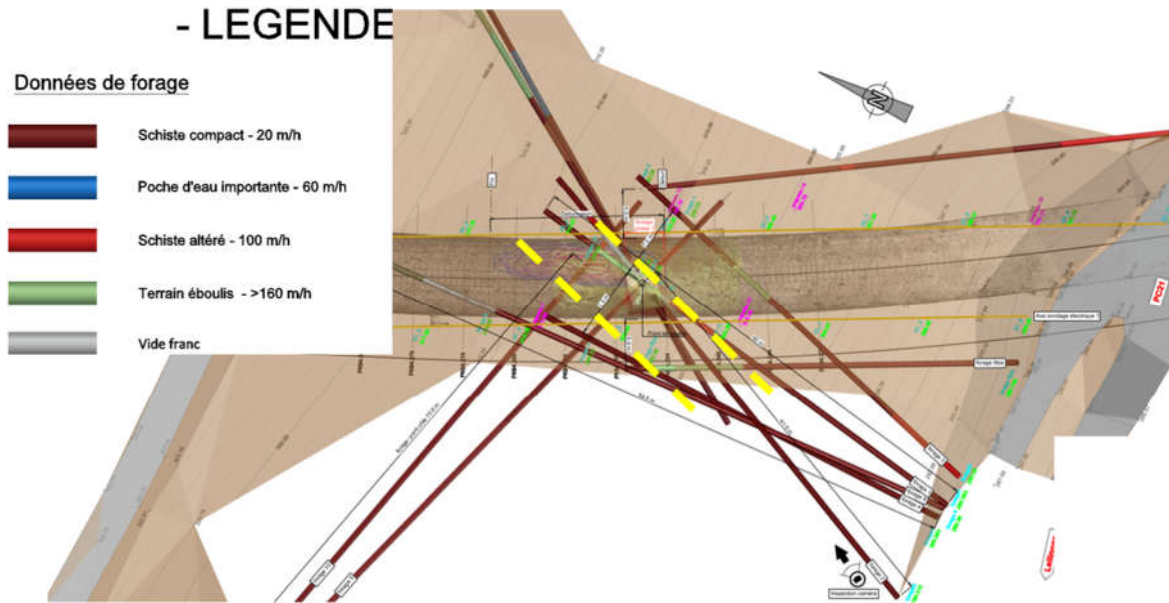
Finally, the data from the reconnaissance boreholes and the geophysical studies are compatible with observations suggesting the presence of a faulted/deconsolidated zone located to the east of the tunnel and intersecting it close to the collapsed zone (NE-SW direction). The boreholes also show that the funtis resulting from the collapsed zone rises upwards in the form of a “chimney” rather than spreading laterally. This is compatible with a slide that would have occurred along weathered, clay-filled planes that would have been destabilised by the removal of the vault. In addition, the works on the vault were carried out just after a long period of dry weather, which led to the clay joints being transformed into cohesionless dry joints. Figure 4 summaries the results that can be interpreted from the reconnaissance boreholes.

**Figure 4.** Possible orientation of the deconsolidated/faulted zone (in yellow) based on reconnaissance boreholes

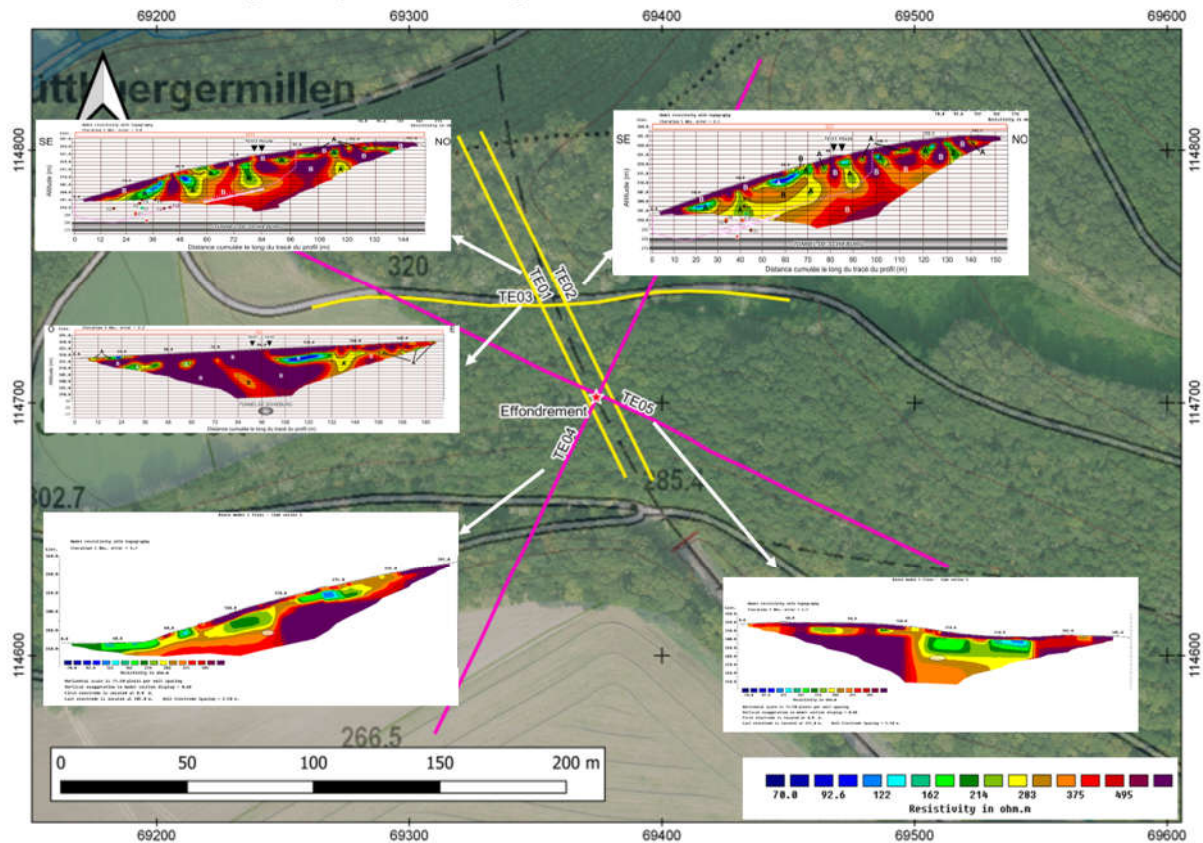
Additional geophysical measurements (electrical tomographies) have enabled us to refine our understanding of the structural situation at the study site. The various results of the geophysical studies suggest the presence of several deconsolidated zones (one in the immediate vicinity of the tunnel and another further east), probably linked to the presence of one or more faults.

**Figure 5.** Location of electrical tomographies (yellow lines: 1<sup>st</sup> phase, magenta lines: 2<sup>nd</sup> phase) and results obtained

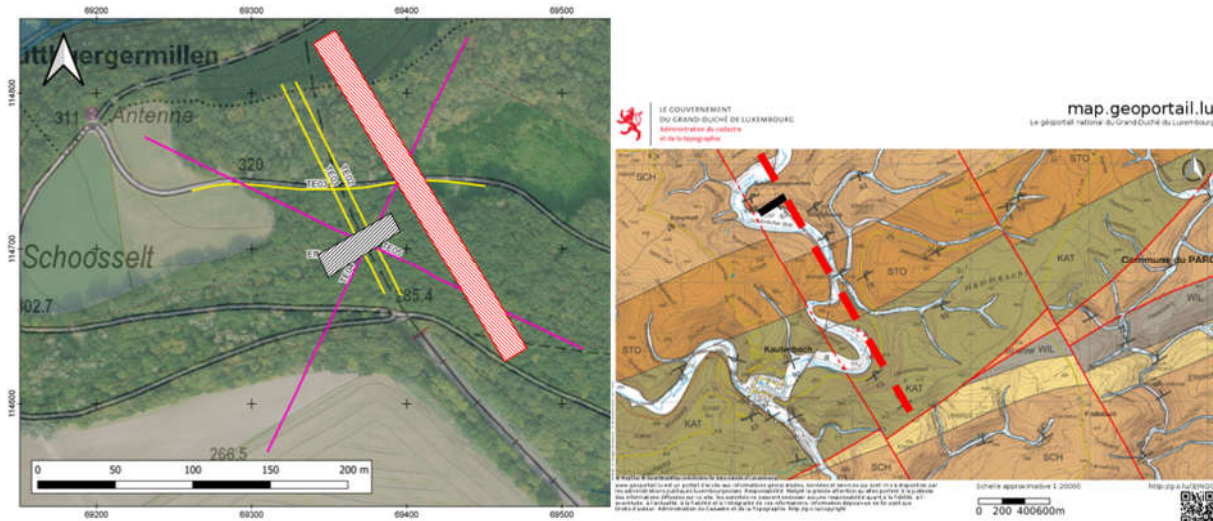
We thus have both a fault parallel to the main fault shown on the geological map and passing to the east of the tunnel (fault shown in red in Figure 6) and a fault perpendicular to the above-mentioned fault, which was also revealed by drilling (see Figure 4), and which intersects the axis of the tunnel in the collapse zone (fault shown in black in Figure 6). These 2 faults are thought to form part of a system of strike-slip faults (although it cannot be ruled out that they are also vertically dipping) linked to the various faults shown and supposed on the regional geological map, as illustrated in Figure 6, right.

**Figure 6.** On the left: interpretation of the position of potential faults (red and black) based on electrical tomography and field observations. The yellow and magenta lines represent the axes of the electrical tomographies (see Figure 5). On the right: transfer of these faults (red and black dashes) on an extract of the geological map (faults are represented on the geological map by red lines)

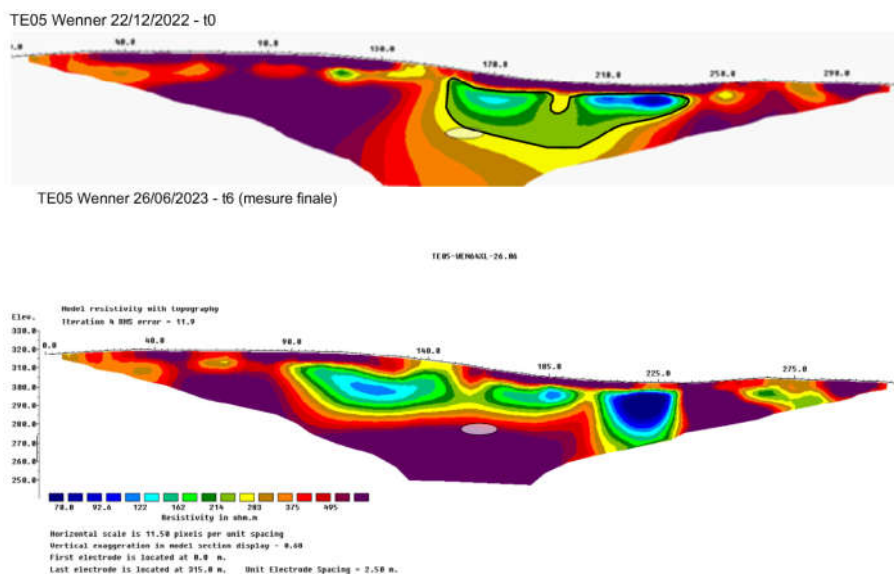
Geotechnical assistance was provided throughout the safety worksite. This was done by checking the injections using electrical tomography and core sampling from the tunnel at various key stages once the works inside the tunnel were possible under safe conditions. For the geophysical monitoring, the 325m tomographic profiles mentioned above were used, applying 2 different analysis protocols (Wenner and Schlumberger), with an initial intervention serving as a “0” measurement and control measurements at different time intervals. A comparison between the initial and final measurements clearly shows an increase in resistivity in the vicinity of the tunnel. This is particularly evident in the profile shown in Figure 10. The increase was most noticeable after the injection work from the vault inside the tunnel.

**Figure 10.** Comparison between the initial measurement and the final measurement showing the increase in resistivity around the tunnel

The geophysics also confirms that the injections did not remain localised to the boreholes, but that the grout probably spread over a fairly large area around the tunnel, which is also confirmed by grout spills observed along the path rising above the tunnel.
