## INVESTIGATION WORKS AND REMEDIATION DESIGN OF A ROAD LANDSLIDE IN HRVATSKO ZAGORJE

Road infrastructure, landslide, investigation works, remediation works, Hrvatsko Zagorje

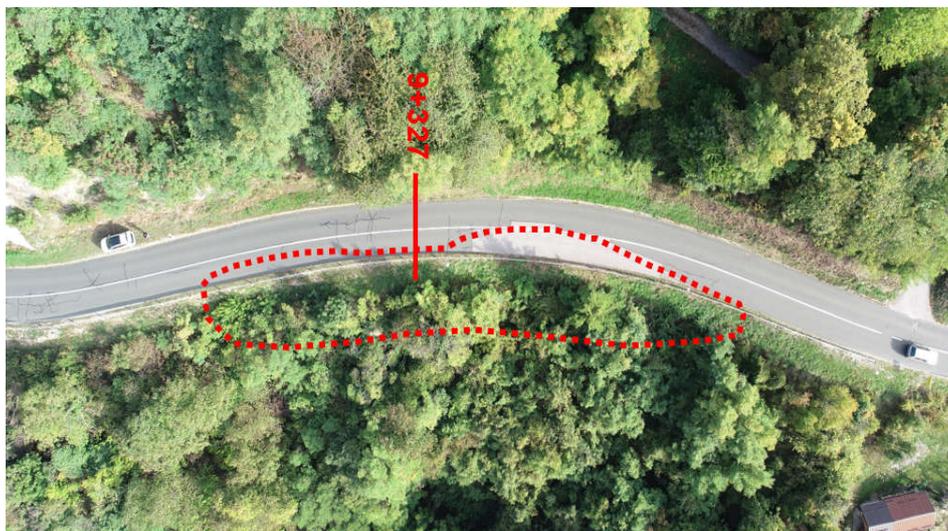
**Figure 16.** Area of instability and planned remediation, State Road DC206

planned remediation is in the area of road subsidence, specifically around a landslide on the downhill slope at km 9+327 of the State Road DC206, as shown in Figure 1.

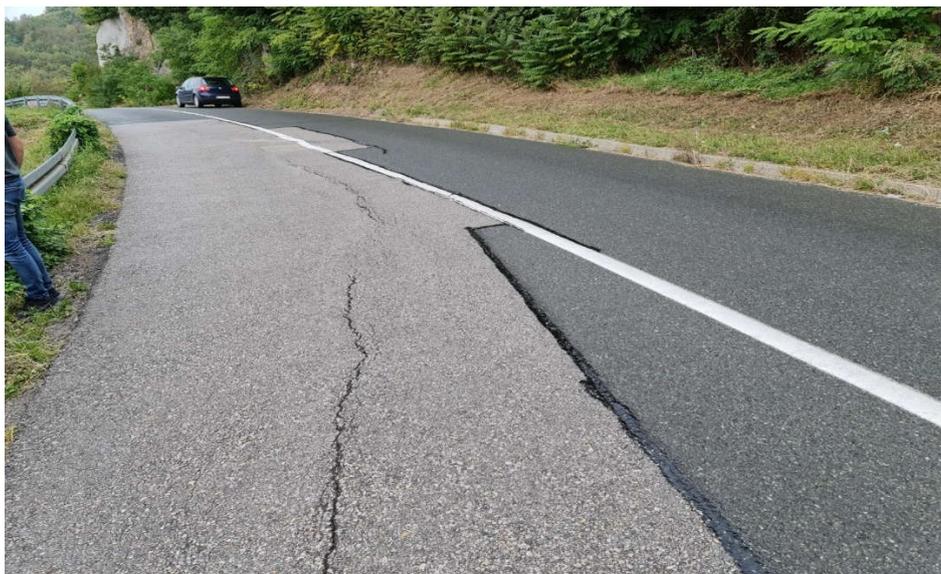
**Figure 17.** Western part of the road with developed crack about 15 meters long

An engineering visual inspection revealed that there was no rainwater drainage, instead, water is partially drained via curbs along the uphill edge of the road, directing water along the longitudinal gradient. Most of the rainwater flows down the slope, driven by the transverse gradient of the road. Surface drainage is further hampered by accumulated material in the narrow area next to the curbs. The accumulation of material on the uphill side is a result of water erosion and the washing away of cover material. Figure 2 shows a crack about 15 meters long, observed on the western part of the intervention area, located 1 meter from the edge of the road. The figure also shows a very steep slope covered with dense vegetation on the uphill side.
