RESTORATION OF DAMAGE TO A PROVINCIAL ROAD IN THE REGION OF ATTICA (GREECE) AFTER A DISASTROUS WEATHER EVENT

NIKOLAOS TAVOULARIS ¹, AGGELIKI KONSTANTARA ¹, AGGELIKI ZIAVRA ¹, LEONIDAS SOTIROPOULOS ²

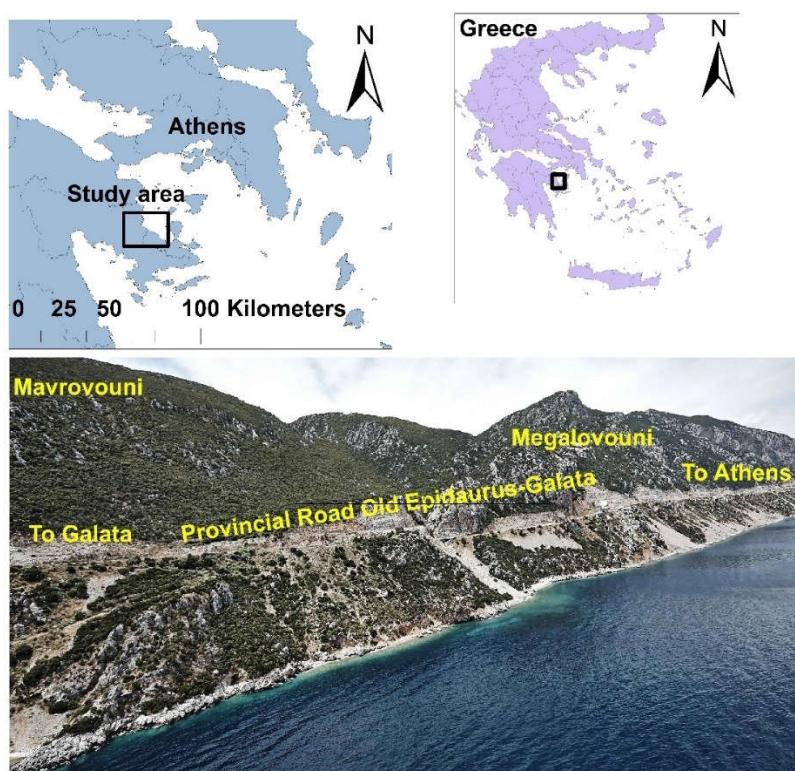
In the area of interest (Figure 1), apart from the manifested failures, the presence of a significant number of large rock blocks has been noted, most of which are in marginal equilibrium, with a risk of toppling, sliding and falling within the road.

Figure 1. Overview of the study area of the Provincial Road Old Epidaurus-Galata (view from Trip in View site)

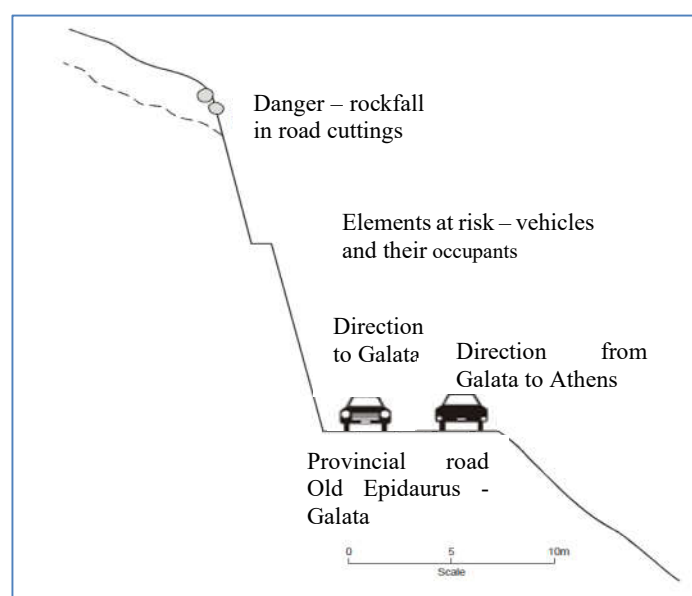
Figure 4. Characteristic segment of the Provincial Road Old Epidaurus – Galata which is part of the suburban road network of Attica Region.

This road was constructed at the beginning of the first decade of millennium. The 31 cuts in the road were constructed at relatively steep slopes. The last at least twenty years, in many parts of the slopes, there are remnant effects of poor blasting practices used in excavating rock slopes as well as stress relief following excavation. According to historical recordings from the Directorate of Technical Works of Regional Unit of Piraeus & Island, there have been occasionally rockfall incidents per year with boulders ranging in size from 25 cm diameter to 1.2 m diameter. The cuttings are in similar climatic conditions, geological background and topographical characteristics. Based on the recorded boulder impacts on the road surface, it is assessed that 50 % of rock falling from the slope will impact on lane with direction to Galata and 50 % of rock falling from the slope will impact on Lane with direction to Athens (Figure 4).
